## 6. SEAVIEW PARK CONNECTION – FUNCTIONAL DESIGN

### 6.1 CN RAIL CUT TO FAIRVIEW CEMETERY

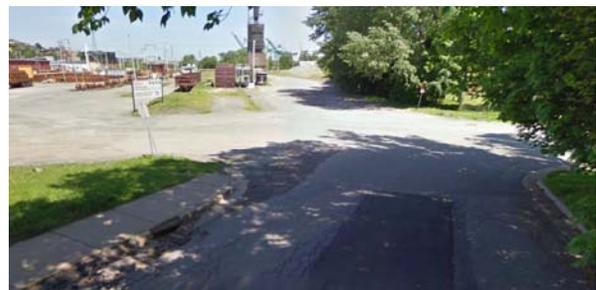
Progressing to the north, the trail will cross the driveway to the CN Fairview Shop which is currently a wide gravel driveway allowing access to a number of different areas of the yard. It is recommended that this driveway be reconstructed to meet typical access management guidelines for width while still permitting the truck

movements required by the yard. There appears to be significant opportunity improve this driveway from an AT perspective to minimize the exposure of pedestrians and cyclists to vehicle and truck traffic.

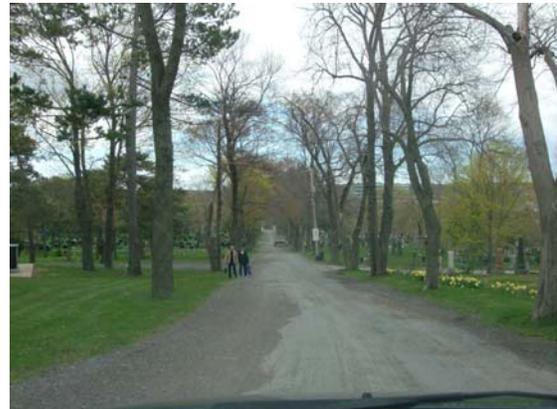
The existing roadway though the cemetery is approximately 5 metres in width and it is assumed that the full width of the roadway will be paved to accommodate the active transportation thoroughfare. Paving will extend from Chisholm Avenue through to Windsor Street and will respect the existing grades of the roadway with minor adjustments as required.

Upgrades to the connection points at Chisholm Avenue and Windsor Street will be required to facility smooth and safe transitions to the adjoining trails.
